Aberporth Coastal Repair

Ceredigion
County Council

Aberporth
Ceredigion

2014

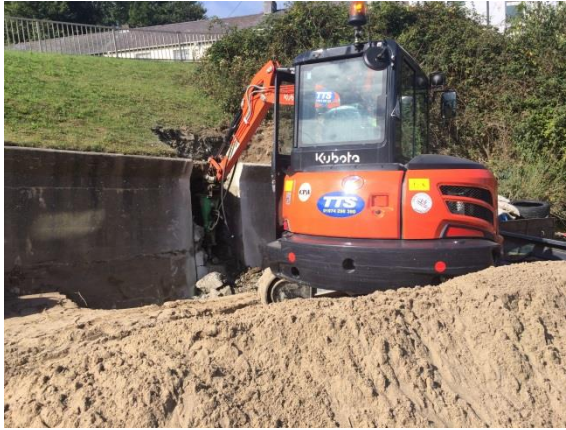
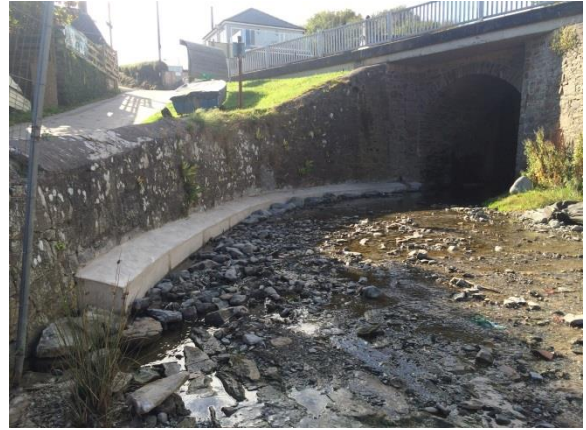
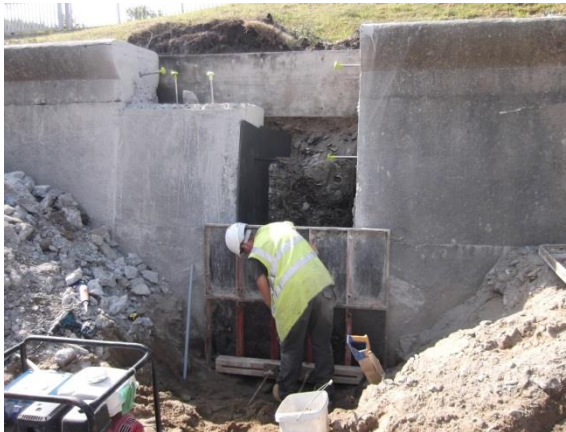
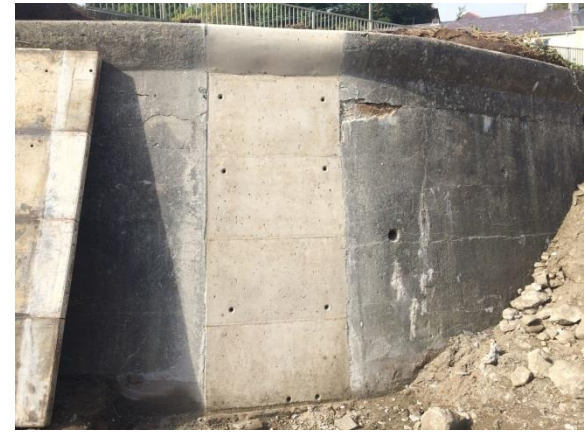
The works involved coastal repairs of the flood defence walls to Aberporth Harbour. The existing wall needed to be removed and replaced with a new concrete section. Underpinning of an old arch bridge was also necessary.

- Excavation of sand to expose existing sea wall foundation.
- Cutting through the existing 800mm thick sea wall and removing a section ready for repair.
- Installation of stainless steel dowels.
- Erection of formwork and false-work for new wave return wall.
- Underpinning and concrete works.
- Landscaping and fencing works
