**Alltyblacca Highway Support**

Ceredigion  
County Council

Alltyblacca  
Ceredigion

2014

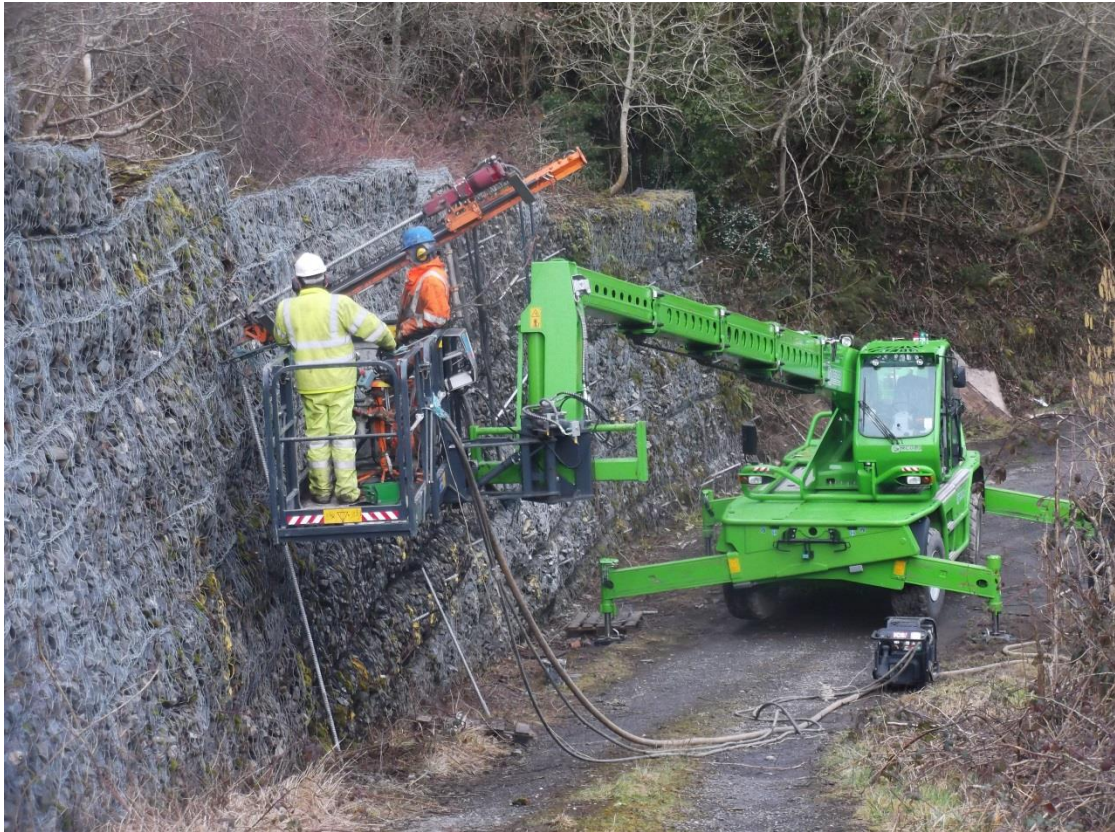
The works consisted of supporting an existing gabion wall which was in danger of failure. The gabion wall was supporting a highway and pavement. Soil nails were used to support the gabion walling with steel beams used to span between the soil nails.

- Installation of soil nails by use of a Merlo and man cage.
- Installation of sleeves within existing gabion basket.
- Grouting of soil nails and stress testing.
- Landscaping and fencing works.
